<b>Consultee Response</b>	Built Historic Environment
<b>Consultee</b>	Jane Corfield
<b>Response Date</b>	28.05.2026
<b>Reference Number</b>	25/LBC/00515
<b>Location</b>	Former Tunstall Library and Baths, Drill Hall and 17-19 Greengates Street, Tunstall, Stoke-on-Trent
<b>Description</b>	Proposed selective demolition, extensions, elevational alterations, external stores and sub-station enclosures, and associated internal interventions (Listed Building Consent)
<b>Case Officer</b>	David Clarke

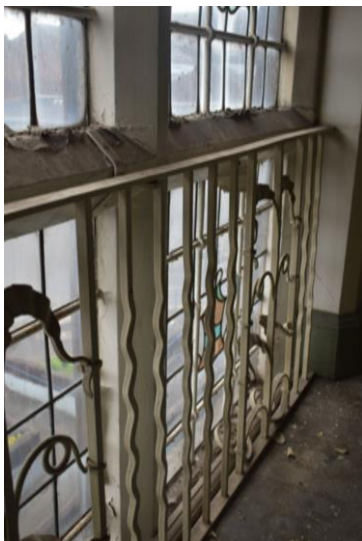
**Photograph 3.4.75 in the heritage statement** seems to suggest non-openable fixed leaded lights into sandstone with a decorative wrought iron grille in front. This area is high in significance according to the statement, but the drawings suggest complete removal despite contradictory text. I conclude that the drawing does not support the heritage statement and the works are harmful to the significance of the building. The **room detail sheet for LS001** does not comment on the windows. **Donald Insall Room- by-Room Assessment of Impact for F001** (the same room) does not mention the windows. The window schedule does not mention these windows.

I cannot, however, see any timber “pieces” in the original window. In my opinion this drawing is not fit for purpose. I do not know what ABC and D relate to. There is no section showing the window at floor level as the photo below. D seems to suggest an opening light. The wall is insulated in the detailed section, but not on the other sections. A note on the drawing says all windows are to be replaced, contradicting the other notes.

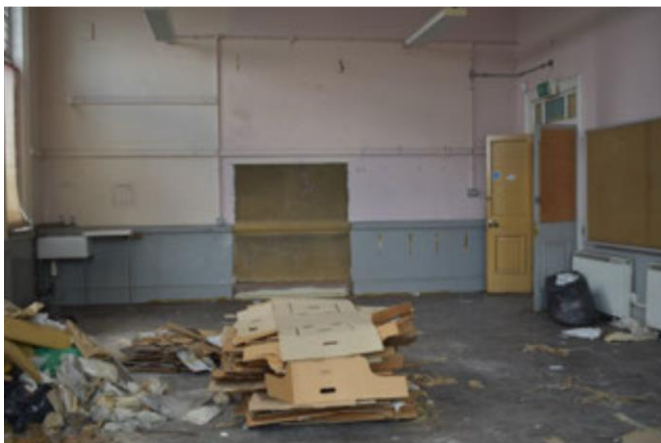
LD101 looks like this in the heritage statement:

A pair of double doors with raised and fielded panels below glazing, itself probably replaced with a board based on the fact that the statement goes on to say that these doors match those to FO14 which are glazed.

This door is shown incorrectly as fully glazed or panelled, not as photographed.

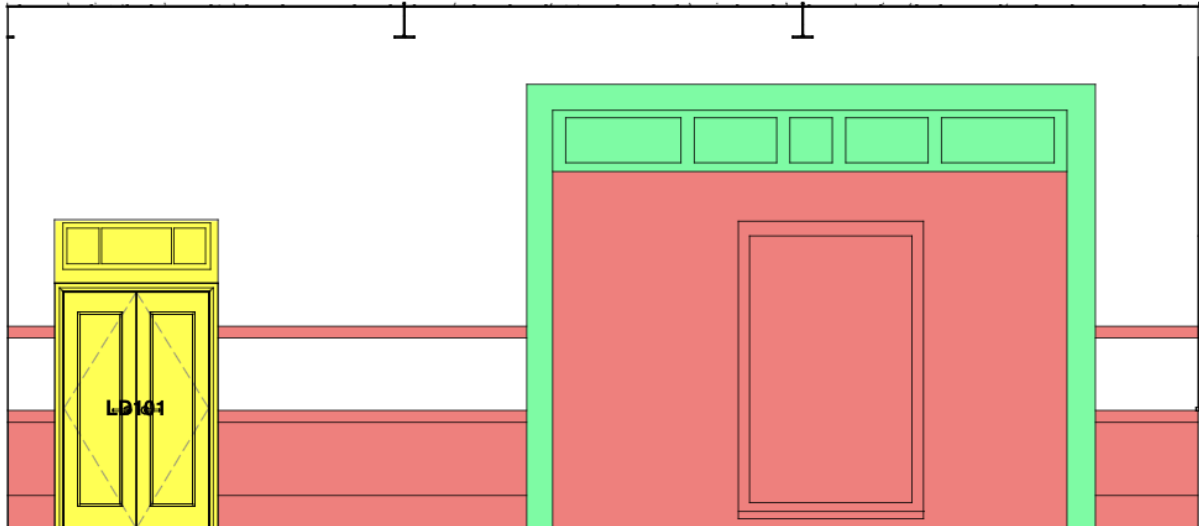
LD101 door and frame removed and reused in LS007 (as LD264). Wall panelling dado rail, pipework and conduits all removed. Roller shutter and chalk board removed with frame around shutter retained

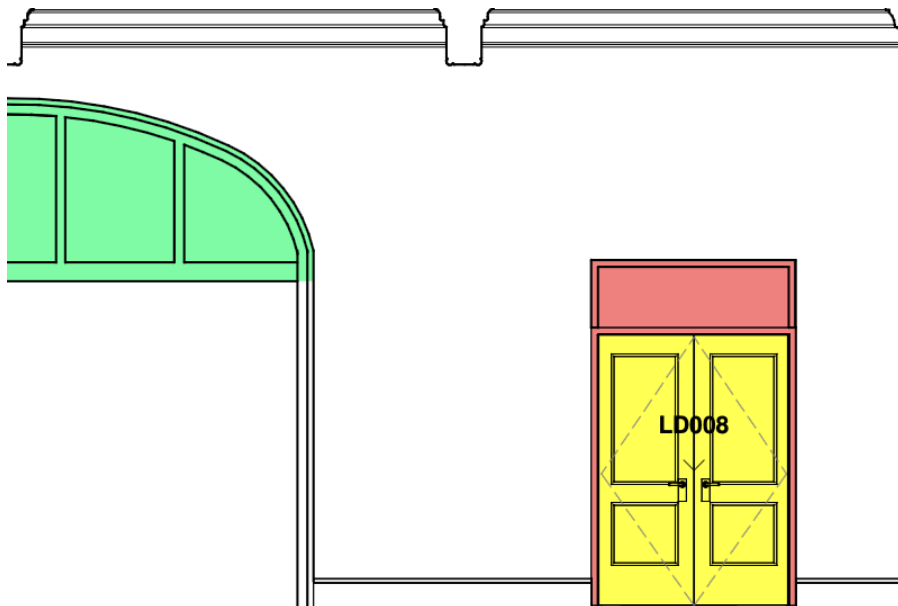
LD008 is shown as

A photograph of this door shows it to be modern and not matching LD101. Why has it been saved? Why has it been placed opposite a door of differing design? These doors will look mismatched and, given there is no clear reason for retention of the modern door or strategic approach, they will not conserve the significance of the building.

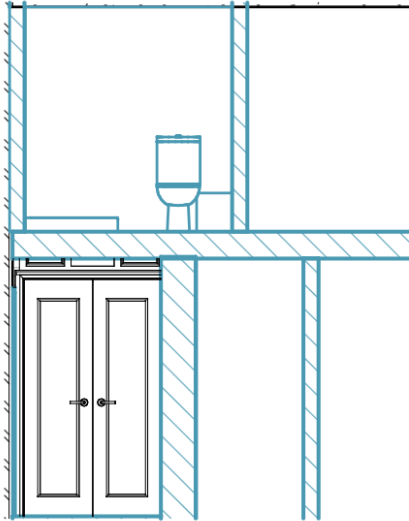
that the door is not reused. This is then contradicted by the room detail sheet that shows it retained, but fixed open and a new mezzanine built across the fanlight. The Room-by-Room Assessment of Impact fails to mention the fact that the floor goes across the fanlight meaning that it won't be seen as the two elements collide.

According to the heritage statement, the door to FO14 which does match LD101 is now called LD100 and is to be moved to S007 a corridor on the second floor. However, the door schedule indicates

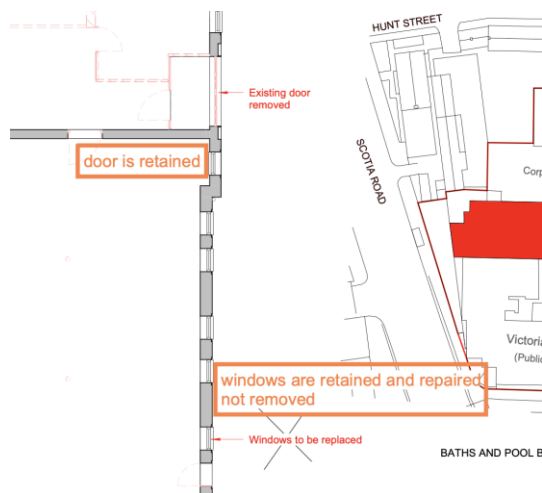
Demolitions drawing **2620 - B-3-08D** has contradictory messages rather than amended drawing causing confusion.
